# HLWTF

# Honeoye Lake Watershed Task Force Newsletter

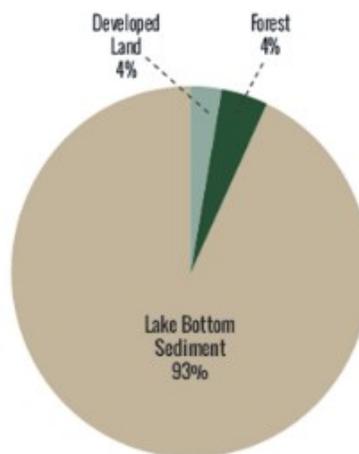
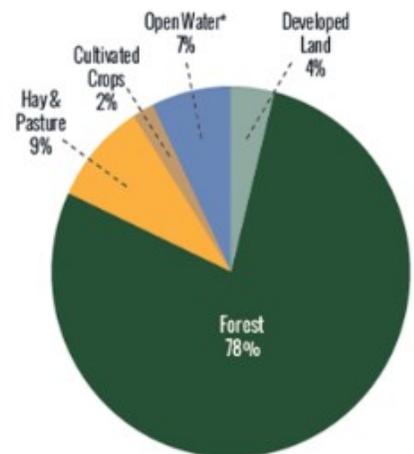
Honeoye Lake  
Phosphorus Loading

These charts show the percentages of different land uses within the lake watershed and an estimate of the amount of nutrients entering the lake from nonpoint sources.

Charts from the NYS Honeoye Lake HABs Action Plan

In 2006, Honeoye Lake was listed on New York State's 303(d) impaired waterbody list due to excessive levels of phosphorus. The EPA requires the state to develop a TMDL for lakes on the 303(d) list to determine the maximum amount of phosphorus reaching the lake from the various sources that will keep algae blooms to an acceptable level ( $\leq 4$  ug/L of chlorophyll-a). The CE-QUAL-W2 Lake computer model was used for this analysis. The lake model takes land use, weather, water flow rates, etc., into account. The model was calibrated with actual lake water quality data and weather data for 2007-2014. The lake model indicated that the two major sources of phosphorus reaching the lake were ~93% from the lake's bottom sediments and ~7% from the watershed during rainstorm events.

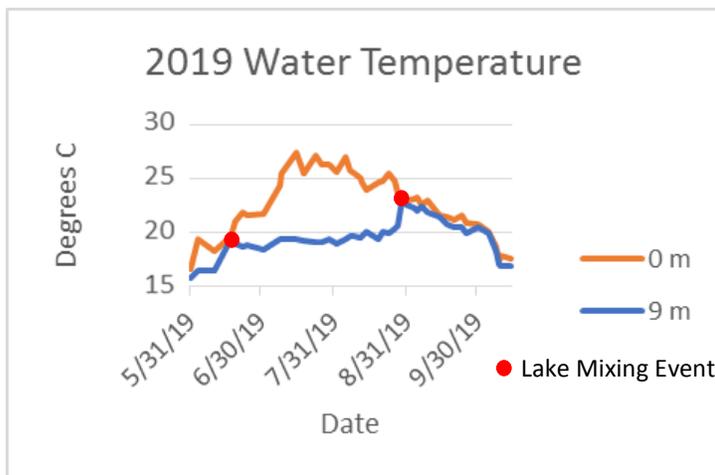
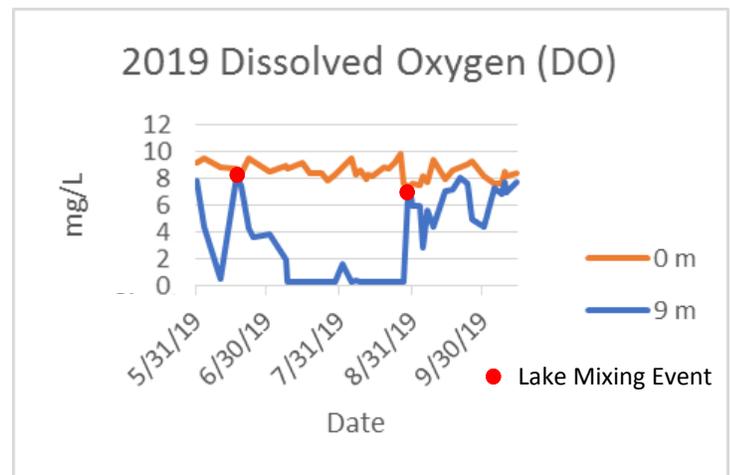
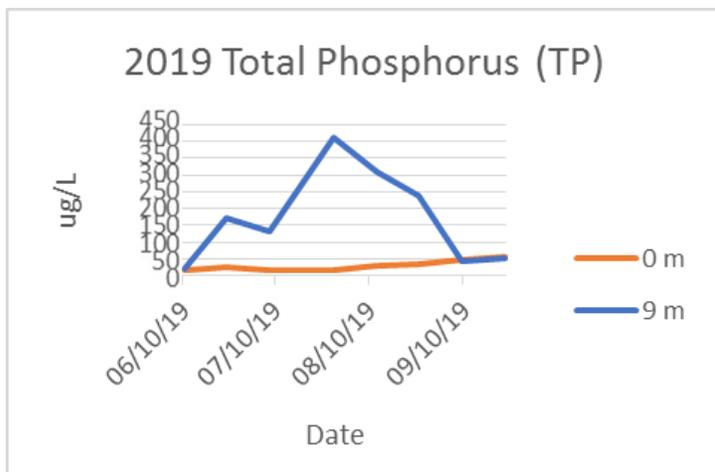
The first two graphs above show 2019 water temperature ( $^{\circ}\text{C}$ ) and dissolved oxygen (mg/L DO) trends. The third graph to the left shows the accumulation of total phosphorus (TP) near the lake bottom in late July reaching a very high level of 410  $\mu\text{g/L}$  (the blue line) and only 16  $\mu\text{g/L}$  (the orange line) near the surface. Anything greater than 20  $\mu\text{g/L}$  at the lake surface is considered eutrophic. The lake experienced some wind generated internal waves in August reflected by the rising blue bottom temperature line and declining bottom blue TP line while the orange surface TP line steadily increased. The internal waves caused some amount of water exchange between the surface and bottom water. On August 27<sup>th</sup> we had a south wind exceeding 20 MPH which led to a complete lake mixing event.

Honeoye Lake is normally polymictic during the summer, meaning it mixes due to strong wind and/or cool storm water every few weeks which will bring up nutrient rich bottom water to the lake surface. This is what provides the majority of the nutrients that fuel our common mid-July through September blue-green algal blooms. You can see the lake's polymictic nature in the 2018 water temperature and dissolved oxygen graphs on the next page; the lake actually mixed at least four times shown by the convergence of the orange surface water temperature line with the blue bottom water temperature line and the convergence of the orange surface DO line with the blue bottom water DO line (when mixing occurs, surface and bottom water are the same temperature and DO is uniform top to bottom). Each mixing event brings nutrient rich bottom water towards the surface fueling our blue-green algae blooms. This is known as internal nutrient loading to distinguish it from nutrients that enter the lake from its watershed, called external loading. Both sources added together describe the lake's nutrient budget, also known as its trophic state.

This long period of lake stratification in the summer 2019 confirmed the findings in the DEC Honeoye Lake HABs Action Plan and DEC Total Maximum Daily Load Report: legacy phosphorus released from the bottom sediments (especially in 2018) contributes a significant amount of phosphorus to fuel our blue-green algae blooms. The DEC recommended an Alum Treatment and/or Aeration System to reduce this internal source of phosphorus. The Honeoye Lake Watershed Task Force is currently considering these mitigation techniques. The DEC is currently evaluating their two small-lake Alum Pilot projects before issuing new permitting guidelines for Alum Treatments in lakes like Honeoye.

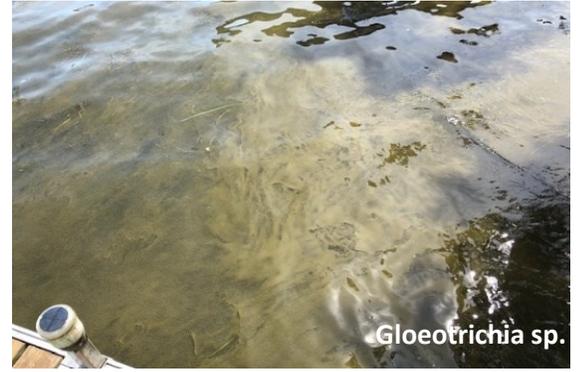
Gloeotrichia sp.

It was present most of July and August in 2019. After the late August mixing event *Anabaena* sp. and *Microcystis* sp. became the dominant blue-green algae species and *Gloeotrichia* sp. rapidly diminished.

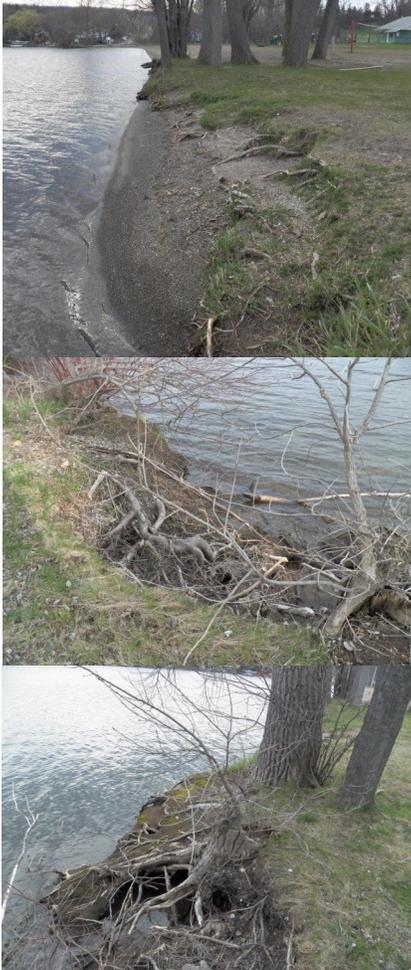
**Before Photographs:**

With funding from the New York State Department of Environmental Conservation Water Quality Improvement Project Grant Program, Ontario County Soil & Water Conservation District and the Town of Richmond installed a natural shoreline stabilization project using coir wrapped soil lifts that incorporate native plant materials. The rock placed in front of the project is necessary to reduce wave energy and ice scour seen at the north end of Honeoye Lake. Existing trees and shrubs were kept in place to keep the shoreline protected and over three dozen additional plantings as well as live stakes were added to promote deep rooted vegetation to further stabilize the shoreline. The NYS DEC promotes the use of natural materials to stabilize shorelines rather than hardened structures such as retaining walls and gabion baskets. A naturally vegetated shoreline helps reduce erosion, filters excess nutrients from entering the lake and provides habitat for fish and wildlife. Ontario County SWCD was able to obtain funding through the NYS Sea Grant to pay for the engineering and design work for this project. This stabilization project can be seen in Sandy Bottom Park, adjacent to the public swimming area.

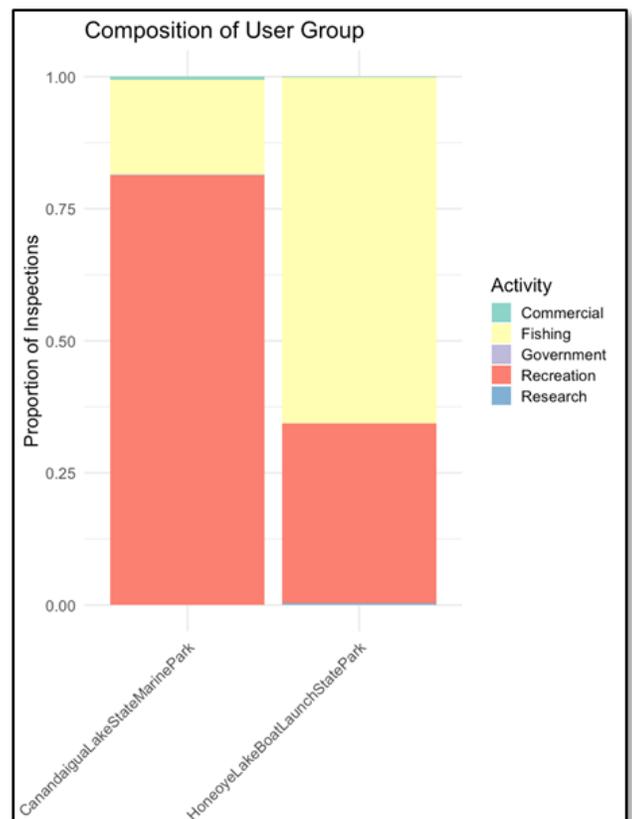
**Figure 1.** Composition of user groups at comparable boat launches in the Finger Lakes, 2019

This figure displays differences in user group proportions between Honeoye Lake State Marine Park, and another State Marine Park on Canandaigua Lake. While activities like commercial and research are consistently low or non-existent for each launch, the proportion of recreation and fishing vary greatly.

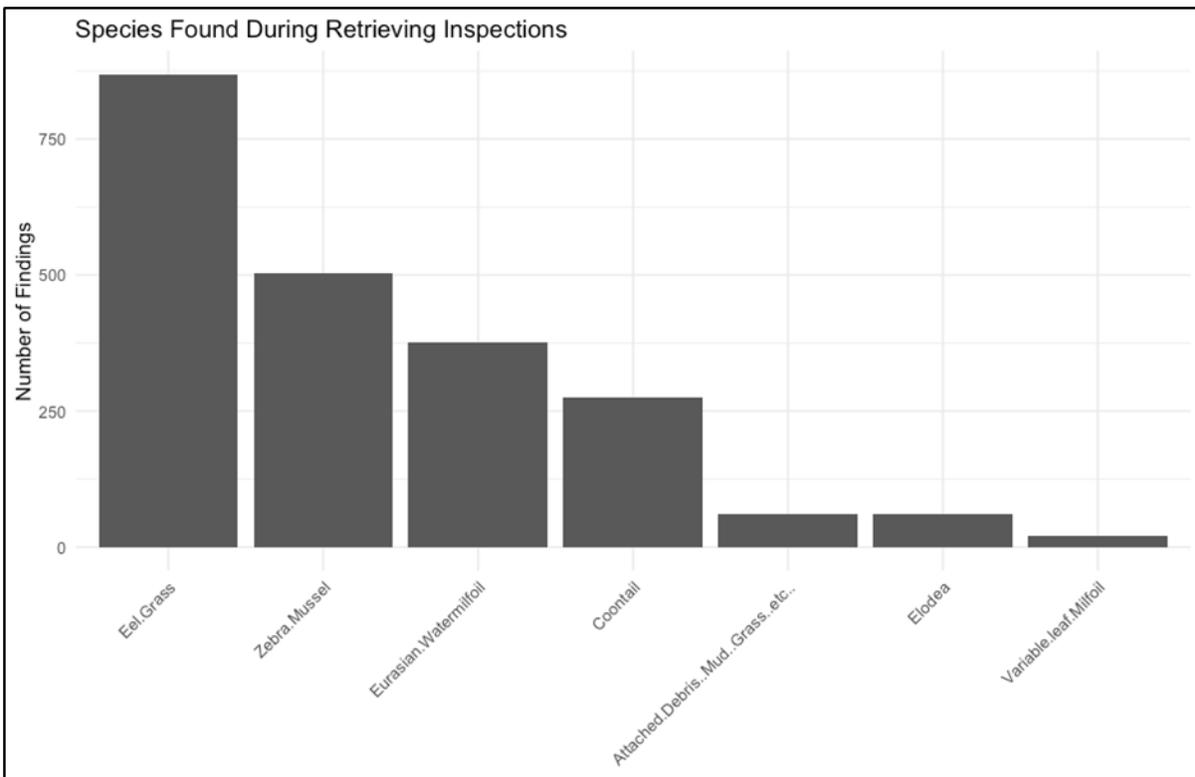
**Figure 2.** Species found during inspection of watercraft launching and retrieving at Honeoye Lake State Marine Park. This figure gives an overview of the different aquatic species found upon exit and entry from the Honeoye Lake. While the native eelgrass dominates the species found during inspections, invasive species like Eurasian watermilfoil and zebra mussels are still frequently found during these inspections.

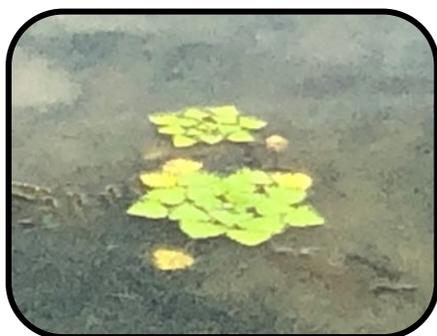
We went to this location and confirmed that the plant was Water Chestnut and took the above picture. When we returned to this location the next day the Water Chestnut plant was gone. We don't know if someone pulled it or it broke loose from the bottom sediments and drifted away. Please keep a watchful eye out for Water Chestnut plants next summer particularly near the Sandy Bottom Park Boat Launch, the NYS Public Boat Launch, and in the Honeoye Lake Inlet. This plant is usually introduced into a water body by a visiting water craft. This is a very aggressive invasive aquatic plant that may establish very dense populations. It thrives in shallow water depths with muddy bottom substrates. It often co-exists with native water lilies. If you see any aquatic plants that you think might be Water Chestnut, please let us know by e-mail at [watershedtaskforce@gmail.com](mailto:watershedtaskforce@gmail.com) For more information on Water Chestnut see the Finger Lakes PRISM Water Chestnut Fact Sheet above.

Last summer a visiting kayaker who launched at the Sandy Bottom Park Boat Launch posted on Facebook a picture they took of a Water Chestnut plant about 30 feet directly south of the Boat launch. A staff member of the Livingston County Planning Department saw the picture of a Water Chestnut plant and reported it to us.
